**THESE LIFTS ARE DESIGNED
FOR MANY PASSENGER CARS,
LIGHT TRUCKS AND VANS**

**MP-28A SPEC 3860
MP-28E SPEC 3861
SERIES V**

**MP-810A SPEC 3862
MP-810E SPEC 3863
SERIES V**

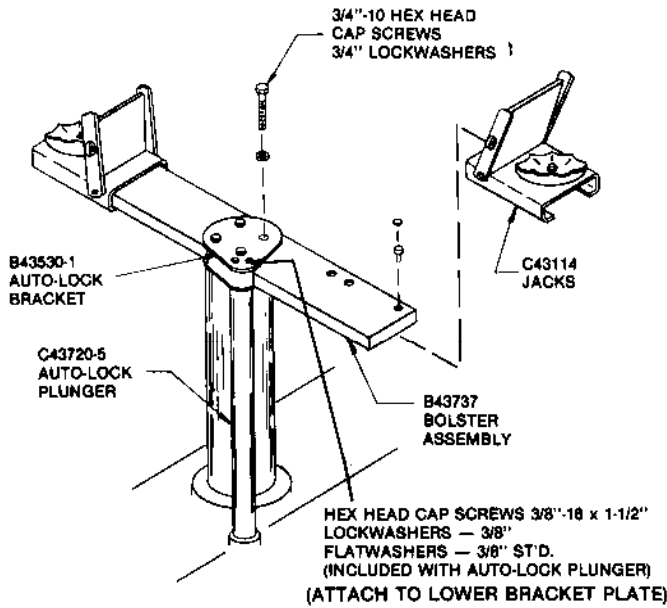
SUPERSTRUCTURE ATTACHMENT - FRONT

NOT SHOWN: CYL. POSITIONING HANDLE
(B42887)
